Master-Thesis in Conservation-Restoration

Assessment of Uncovering 14th C. Wall Paintings at Château de Germolles

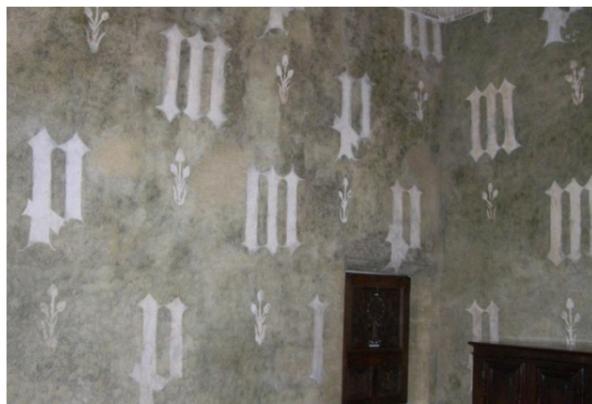
Fig 2: Dressing room of Countess of Nevers, Southwest corner, wall paintings decorated with letters and teases, © SUPSI 2016.

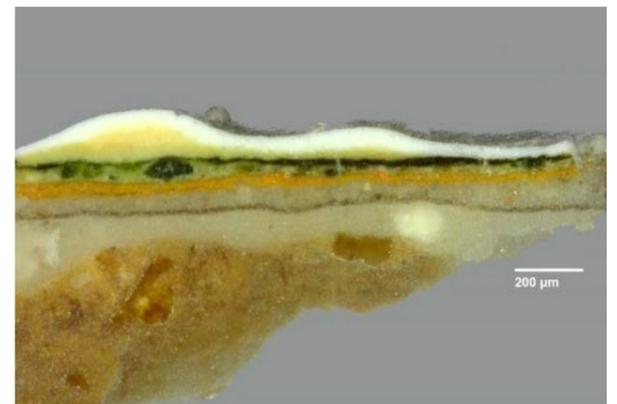
Fig 3: Photomicrograph of the cross section showing the double green layer underneath the lead white paint layer, © SUPSI 2015.
